**BUREAU OF LAND MANAGEMENT
ELKO FIELD OFFICE
BURNED AREA EMERGENCY REHABILITATION TEAM**

Elko 21 Complex

SOIL AND WATERSHED RESOURCE ASSESSMENT

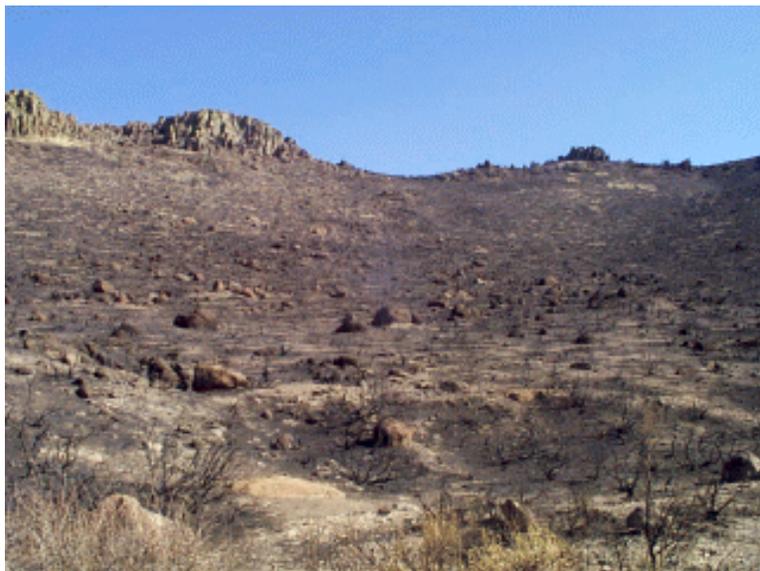
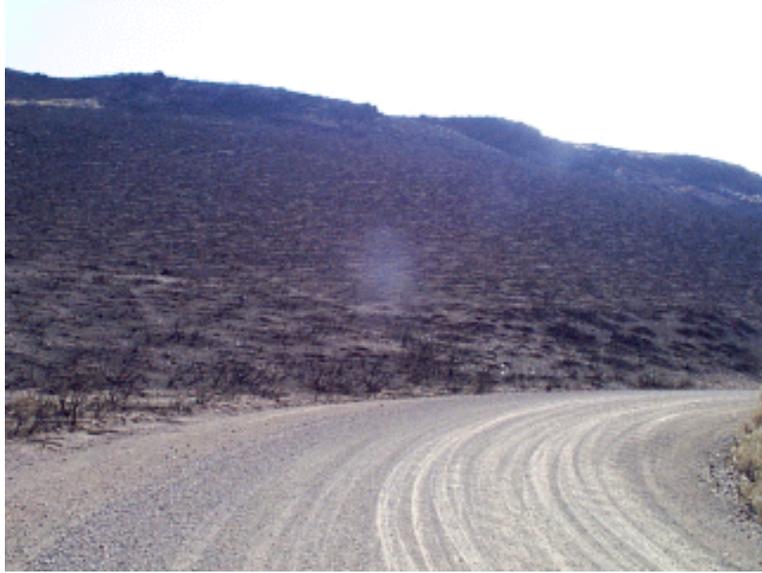
Watershed Response: The area of concern has high runoff potential. Slopes are steep and infiltration rates are slow. Rock outcrop dominates the tops of the slopes. Most of the vegetative cover was consumed by the fire.

Values at Risk/Resources to be Protected: There is a county road running along the southern edge of the fire. Rock outcrops and steep slopes with high runoff potential and increased erosion along the road pose a threat to human life and property.

Proposed location of straw wattles on Vega Fire.

Recommendations: Straw wattles are to be placed on steep slopes and straw bale check dams are to be placed in the ephemeral drainages. The straw wattles will prevent erosion by reducing slope length and slowing the flow of water. Check dams in the ephemeral drainages will also prevent erosion by capturing sediment and will prevent downcutting in the ephemeral drainages.

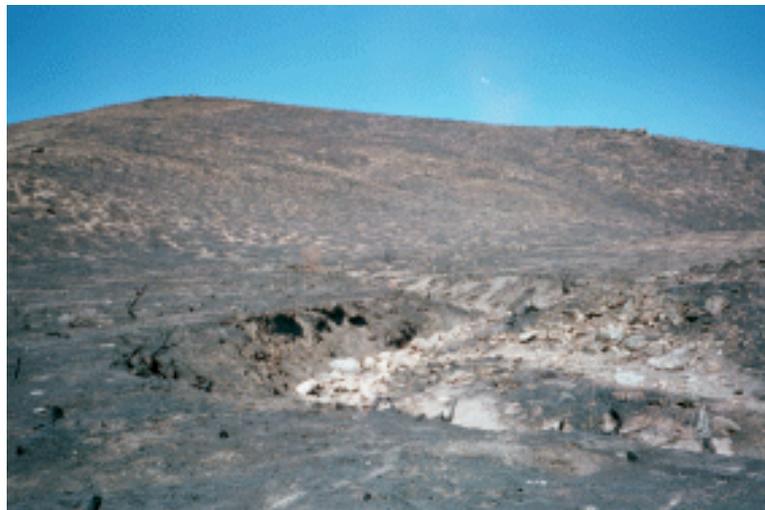
Watershed Response: Runoff potential is moderate near the perennial reach of Dorsey Creek and high along the transition zone and ephemeral reach in Section 35. Dorsey Creek is incised approximately 15 feet in its transition zone and approximately 4 to 6 feet in the ephemeral reach above the transition zone. Erosion along incised banks was observed in the transition zone during a field reconnaissance. Runoff potential along Willow Creek was moderate below Willow Springs and severe in the tributary above Willow Springs. Willow Creek below Willow Springs is incised approximately 15 feet. Active erosion along the incised banks of Willow Creek was observed as well.

Values at Risk/Resources to be Protected: Dorsey Creek is historical habitat for Lahontan Cutthroat Trout (LCT). LCT populations were estimated at 228.8 fish per mile by the Nevada Division of Wildlife in 1985. In 1999, there were no LCT found. In 1984, the Dorsey Creek watershed experienced peak runoffs approaching 100-year storm events. As a result of the increased flow, Dorsey Creek had incised 10-15 feet in the reaches above Dorsey Reservoir and was causing siltation of the reservoir. The lower reaches of Dorsey Creek have since stabilized. Willow and perennial herbaceous plants species have established and are effectively trapping the excess sediment moving through the channel.

Proposed location of Excelsior mat and riparian seeding along Dorsey Creek.

Recommendations: Dorsey Creek drainage should be seeded to establish protective cover through the winter and spring to reduce erosion. Excelsior matting should be placed along streambanks along the ephemeral reach for additional stabilization of the soil. Straw bales should be placed in the ephemeral tributary above the transition zone.

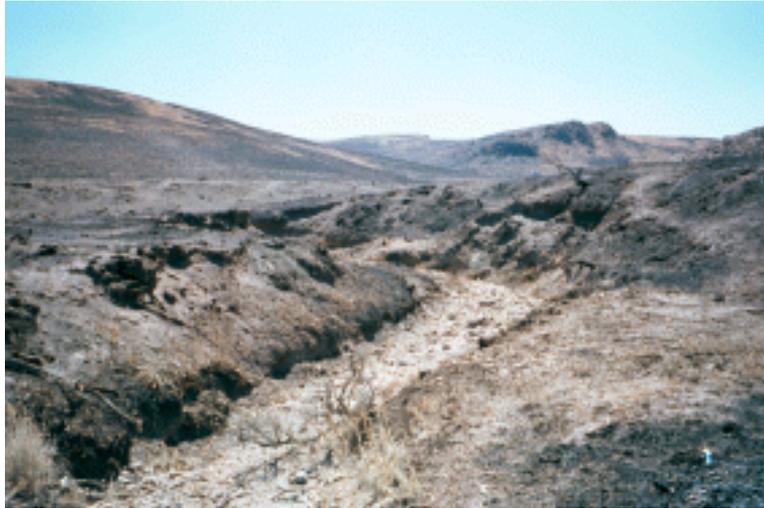
Proposed location of riparian seeding along Dorsey Creek.

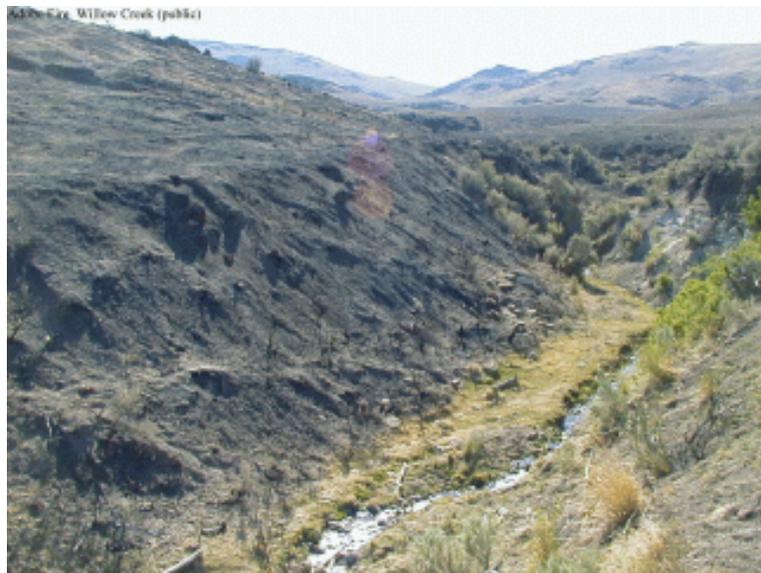
The incised portion of Willow Creek is the result of a headcut moving upstream toward Willow Springs. Increased runoff and sediment moving through the system will result in the headcut moving upstream at a faster rate and eventually draining Willow Springs.

Proposed location of Excelsior mat along Willow Creek.

Excelsior matting should be placed along the incised portion of Willow Creek to prevent erosion. Straw bale check dams should be constructed along portions of the ephemeral tributary to Willow Creek to prevent sedimentation of Willow Springs. Straw wattles should be placed on steep slopes in the headwaters of the ephemeral tributary to Willow Creek.

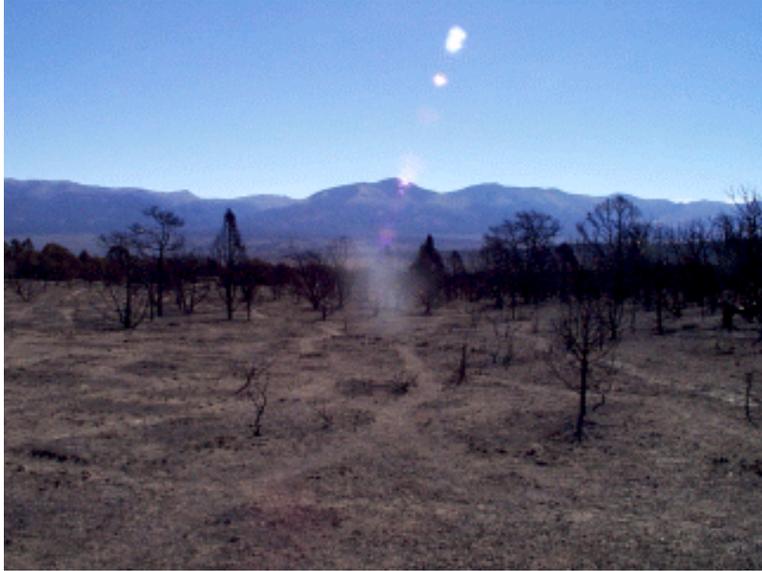
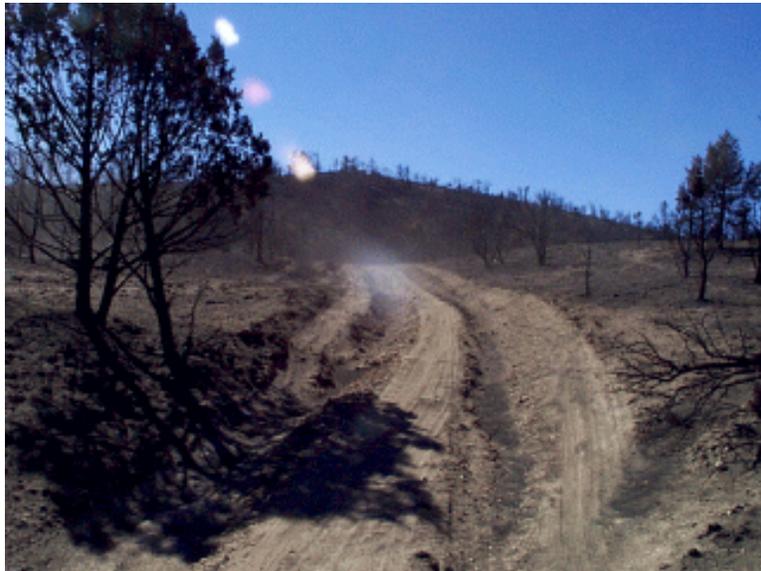
Watershed Response: Runoff potential is high in both watersheds. Ground cover density is estimated at less than 25%. Slopes are steep and have hydrophobic soil conditions. In watershed A to the north, the main drainage paralleling the two-track road was actively eroding.

Proposed location of aerial seeding in unnamed watershed A.

Recommendations: Aerially seed both watersheds to increase ground cover, prevent erosion and decrease runoff. Place flood hazard warning sign in Sec. 35, T. 28 N., R. 61 E.

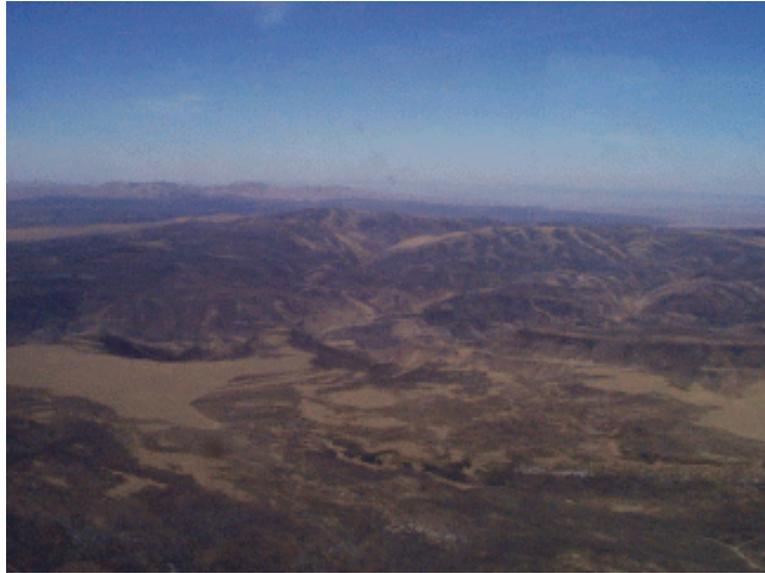
Burn Severity: Burn severity was high in Coon Creek and Stratton Creek drainages. Burn severity was moderate on hillsides in the Goose Creek drainage and moderate to severe in the drainage bottom. There were several live aspen stands on the hillsides of Goose Creek that were not burned which is indicative of low to moderate fire intensity in those areas. Throughout the entire area there were large unburned islands.

Coon Creek and Stratton Creek drainages from the air.

Recommendations: Coon, Stratton and Goose Creek drainages should be aerially seeded to increase ground cover, prevent erosion and decrease runoff. Place flood hazard warning sign in Sec. 22, T. 47 N., R. 68 E.

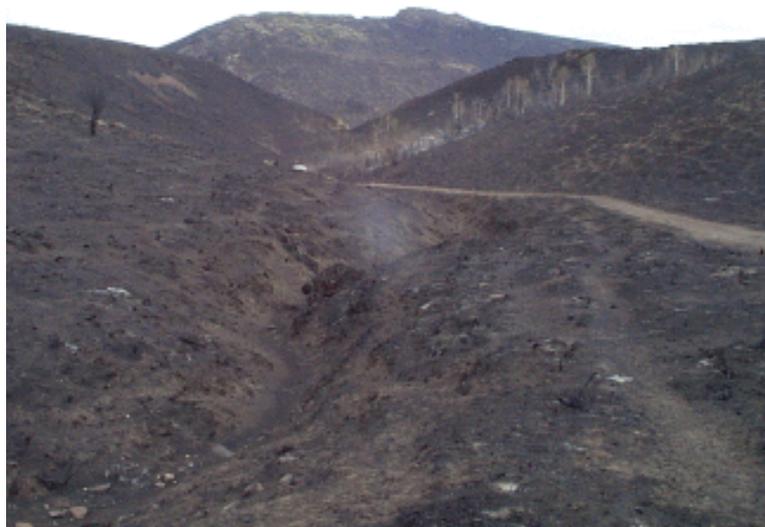
Coon Creek drainage.

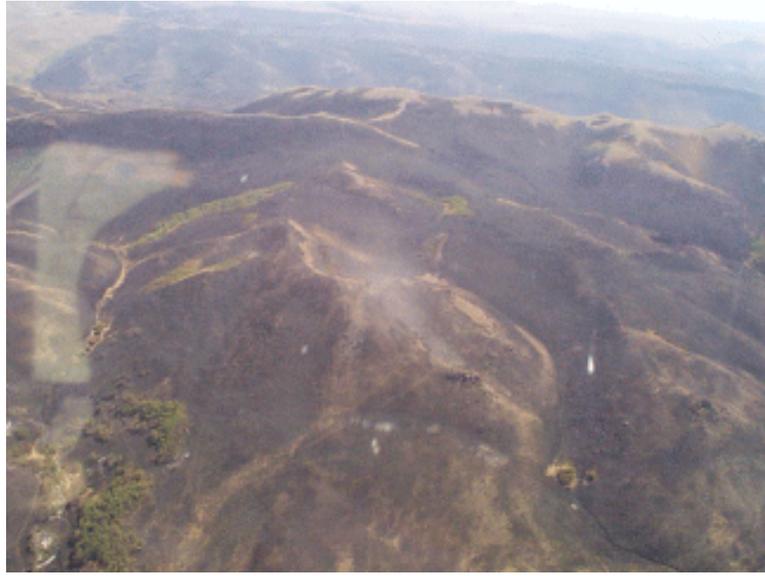
Unburned aspen stands within Goose Creek drainage.

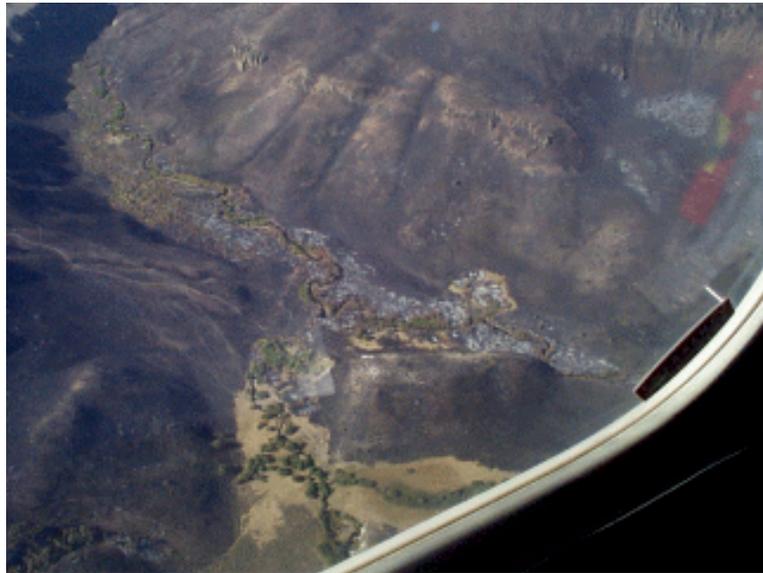
High burn severity in Goose Creek.

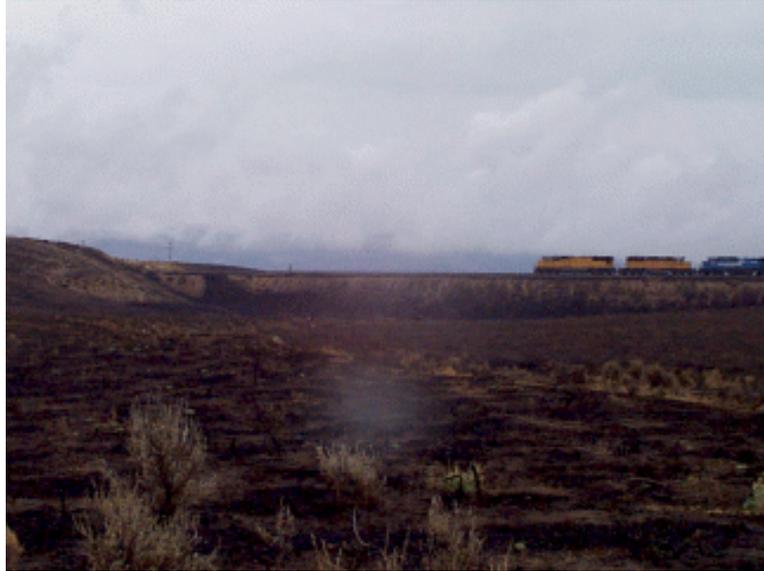
Values at Risk/Resources to be Protected: There are eight culverts along the railroad tracks that could be impacted from the fire with increased runoff. The culvert and railroad tracks at Independence Creek are of greatest concern, because this watershed drains the largest area of the eight culvert sites, it burned most completely, and would have the greatest flow following a precipitation event. The other value at risk, as mentioned previously, is highway 93 if the reservoir at Willow Creek should breach.

Independence Creek drainage near railroad culvert.

A combination of three watershed treatments is proposed in the lower Independence Creek watershed. Aspen matting would be placed along the main drainage from the railroad culvert upstream approximately .2 miles, and along the length of the main tributary (most eastern) that has its confluence to Independence Creek at the culvert. This would stabilize the soil and reduce both wind and water erosion, to reduce the risk of the culvert from washing out and damage to the railroad. Straw bale dams would be placed in five channels just upstream of the culvert where the drainages had moderate to high burn intensity, and the slopes are steep. Lastly, straw wattles would be installed across the steeper slopes on the north side of Independence Creek to reduce runoff and sediment deposition, where past large sediment depositions were noted.

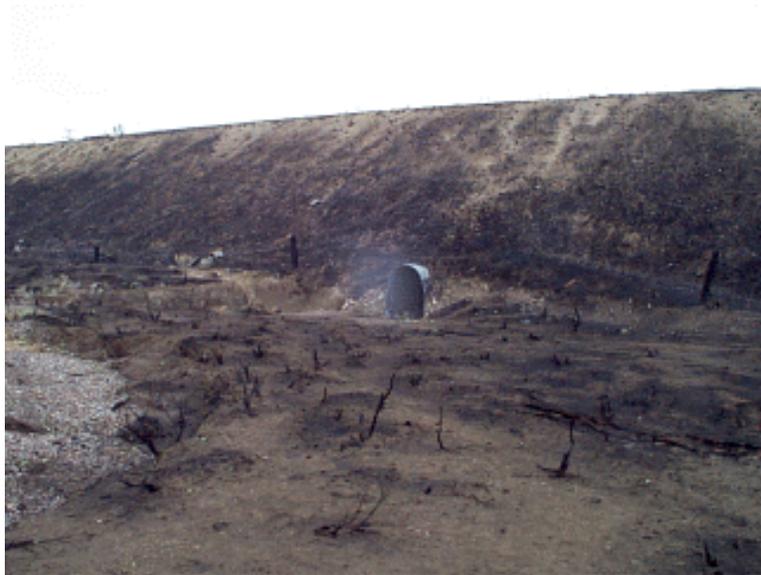
Culvert for Independence Creek.

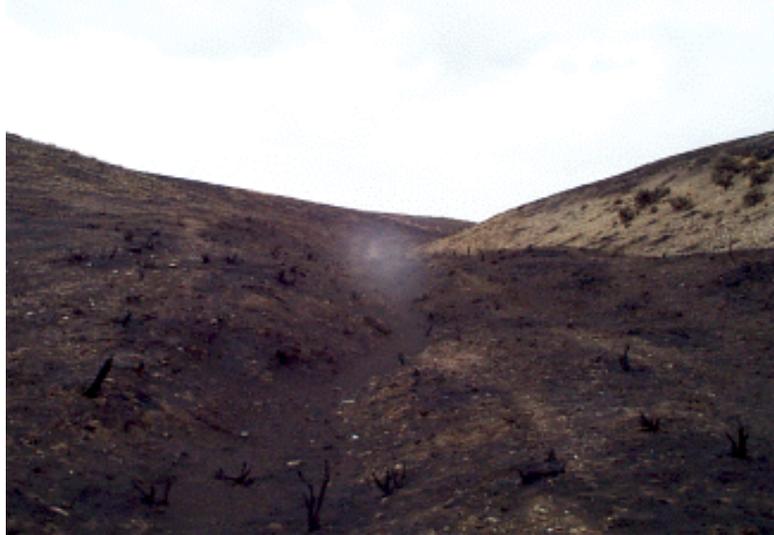
Tributary to Independence Creek above railroad culvert.

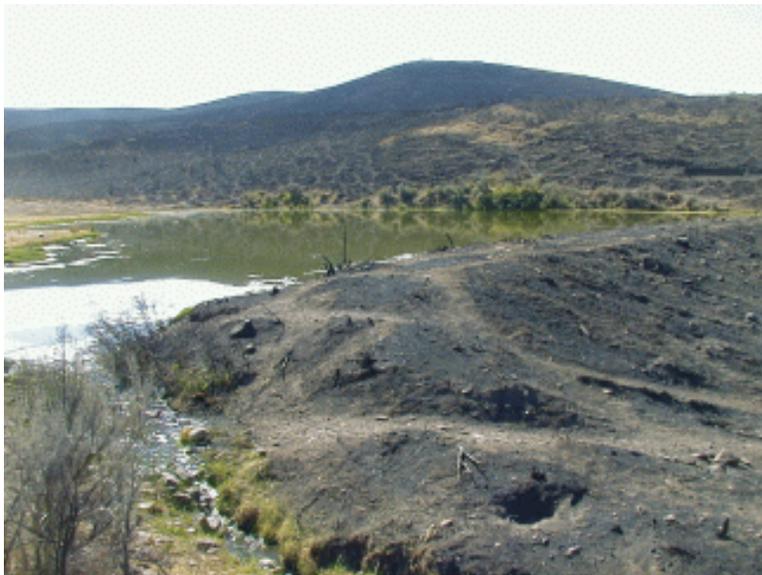
Watershed Response: Willow Creek watershed is of concern because it has high runoff potential, the riparian area is in poor conditions with actively eroding banks, and there is a reservoir at the lower end of the burn that could breach in a large runoff event, sending water and debris flows down toward highway 93. Most of the vegetative cover was consumed by the fire. Portions of Willow Creek seen during a field reconnaissance were dysfunctional. The channel is incised as much as four feet in places with little vegetation, rocks or debris present to protect banks and capture sediment that may enter the stream as a result of the fire. The stream is unstable and would not be able to successfully transport increased flows that could occur following fire.

Overflow channel for Willow Creek catchment.

Recommendations: Nearly all the area in the Willow Creek watershed that needs stabilization is in private ownership, therefore the only watershed recommendation is to place a flood hazard warning sign in sec. 12, T.39 N., R.63 E.

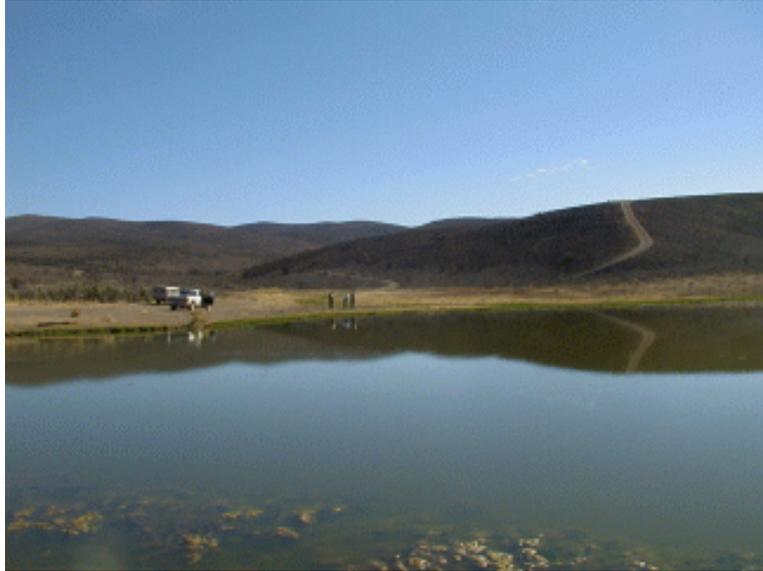
Catchment in Willow Creek drainage.

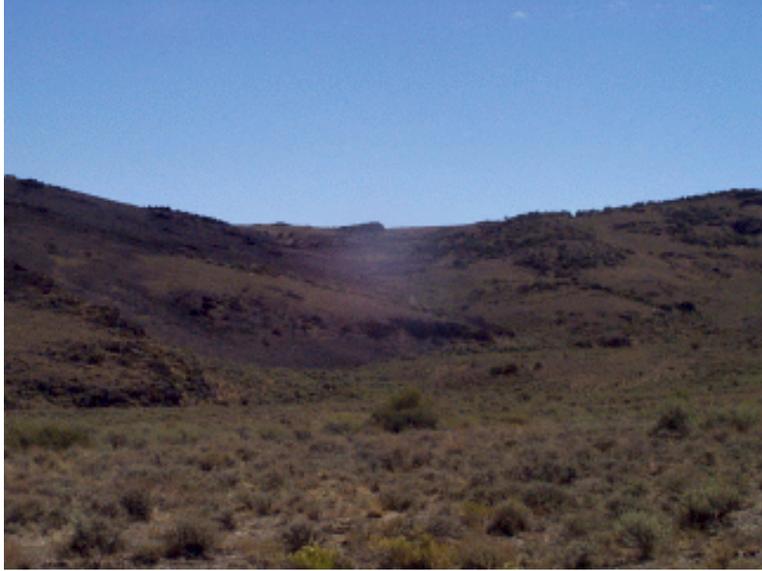
Values at Risk/Resources to be Protected: The road on the southern end of the burn already had rills forming from water running down the road. This problem would become worse following fire, with increased runoff. There are small reservoirs down below the road that could fill with sediment or breach.

Drainage within Mahogany fire that parallels road.

Recommendations: Repair the road and install waterbars with wing ditches as necessary to decrease runoff and sediment moving down the road.
